Technical Bulletin TB-027

Air-Cooled Heat Exchanger Freeze Damage

Revision 0, 1/05/2018, Matt Reed & Ross Putvin

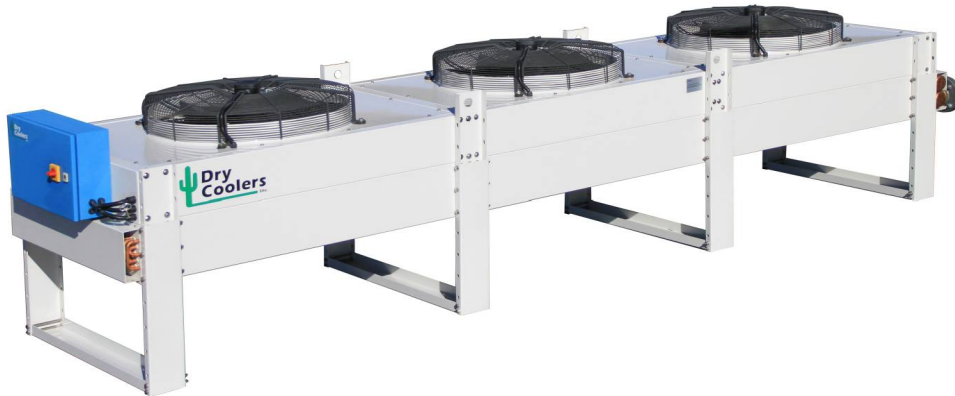
Illustration 1: Air-Cooled Heat Exchanger

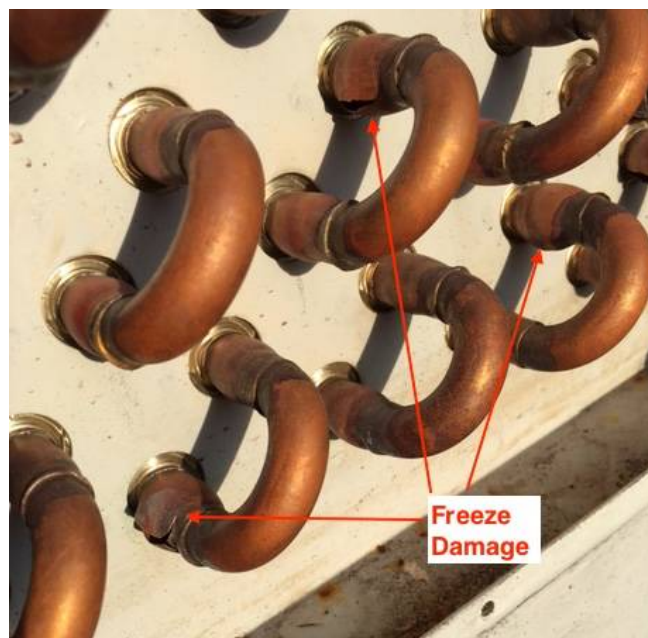
Freeze-damage is caused by insufficient concentration of anti-freeze in the water. As water approaches the freeze point, it begins to crystalize and expand. This expansion creates a substantial amount of internal pressure and will lead to ruptured tubes. Most freeze-damage occurs at the U-bends at the tube-sheet face and will appear as buldging and split tubes (Illustration 2). Most successful repairs have been done by cutting off the U-bend and brazing the tube shut. Unfortunately, this leaves a “dead” circuit in the coil that will not transfer heat. As a result, you can expect a certain amount of loss in heat transfer performance and increase in pressure drop. Be aware that fixing one leak may lead to another leak in the next weakest location/joint. This will likely be an iterative process. Fix, test, fix, test....

Illustration 2: Buldging and Split Tubes Caused by Freeze Damage

Heat exchanger coils have similar construction as condenser coils (thin-walled copper tubes and aluminum fins). Repairing a coil is a delicate operation and should be discussed with Dry Coolers first. Sometimes, we may request a local refrigeration specialist to evaluate the coil and attempt repairs.
